# Walk Around

## F-8 Crusader

Walk Around Number 38  
squadron/signal publications

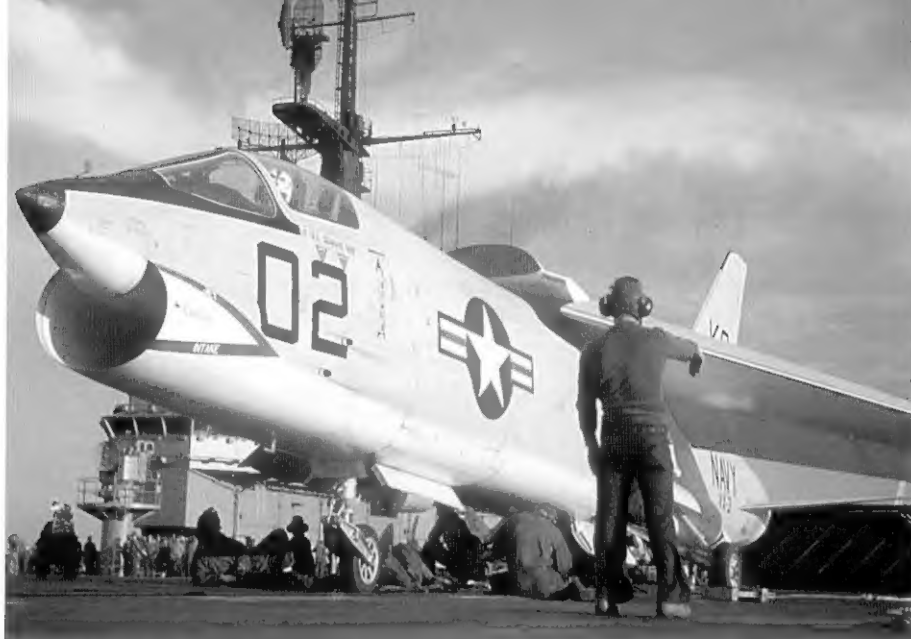
An F8U-1 (02/BuNo 142410) of Air Test and Evaluation Squadron Three (VX-3) participates in early carrier trials aboard USS FRANKLIN D. ROOSEVELT (CVA-42). This variant was re-designated the F-8A on 18 September 1962. Early Crusaders lacked factory-installed in-flight refueling capabilities, which is demonstrated by this aircraft's absence of the refueling bulge on the left fuselage (Vought)

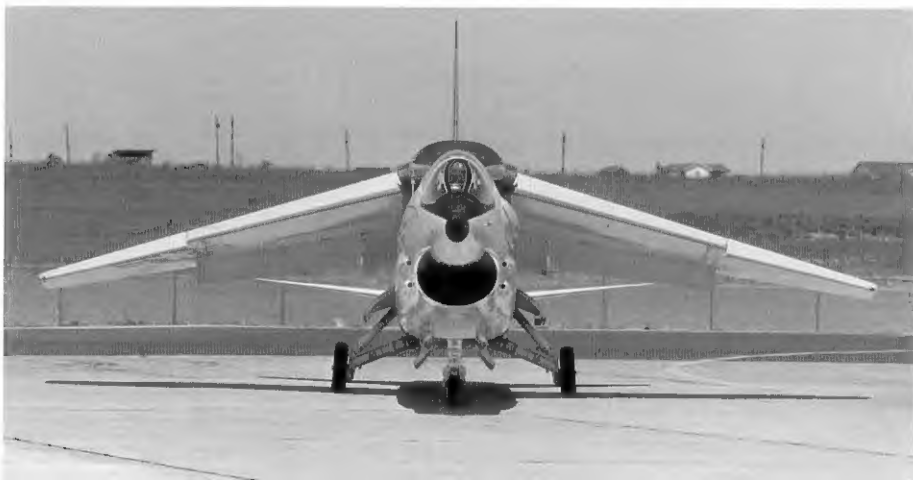
This head-on view of an F8U-1 illustrates the Crusader's unique shoulder-mounted swept wing design. The wing had a variable angle of incidence, which could be raised 7°. In this configuration, the effects of the leading edge droops, flaps, and 5° wing anhedral produced maximum lift. The leading edge droops (also called leading edge flaps) lowered to increase wing camber (surface curvature) when the wing was raised. This increased wing area and improved handling for low speed flight, including take offs and landings. (Vought)

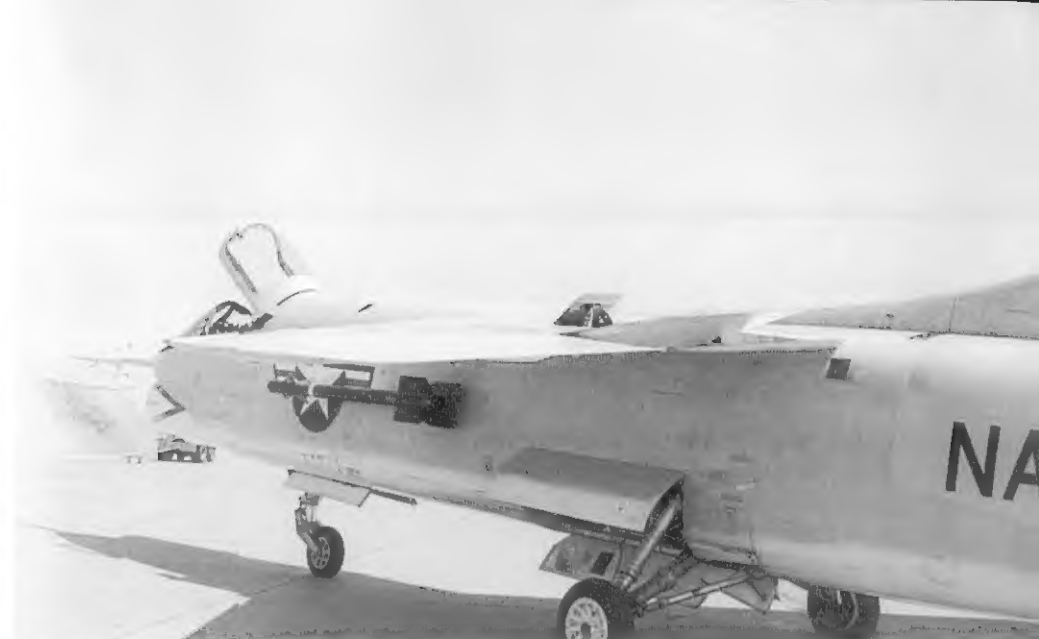
A roll augmentation spoiler was installed flush with the wing's upper surface, forward of each aileron, on F8U-1 BuNo 143772 and subsequent aircraft. The spoilers increased the roll rate at both low and high airspeed. (Vought)

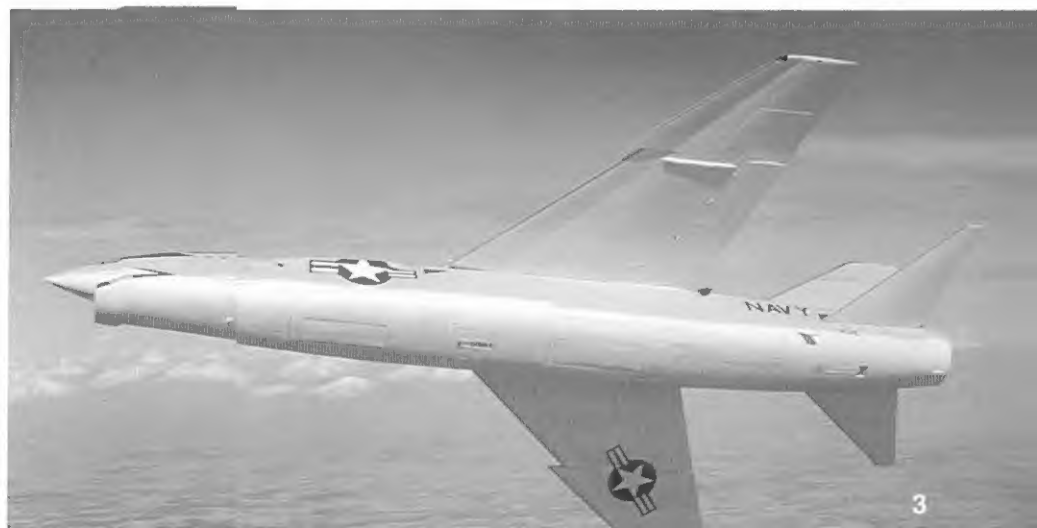
The F-8 design's clean lines are evident in this image of the airframe undersurface. The catapult attachment point was a slot located on the fuselage centerline at station 331, which was between the nose and main wheel wells. This station was 331 inches (840.7 cm) from the forward reference point. Wing and tail surface leading edges were left in natural metal. (Vought)

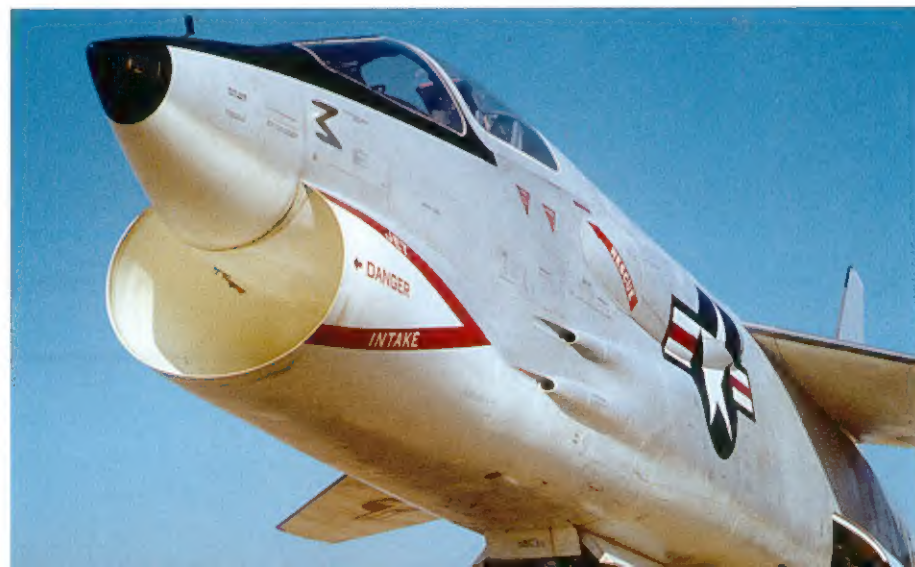
An in-flight refueling probe was installed on F8U-1 BuNo 143702 and subsequent Crusaders, which resulted in a 'bulge' on the fuselage's left side. The strike camera/viewfinder was mounted in the nose at the 3 o'clock position. The yaw indicate vane was mounted in front of the windshield on both the F8U-1 (F-8A) and F8U-1E (F-8B). The E suffix on the F8U-1E designation stood for electronic equipment. (Vought)

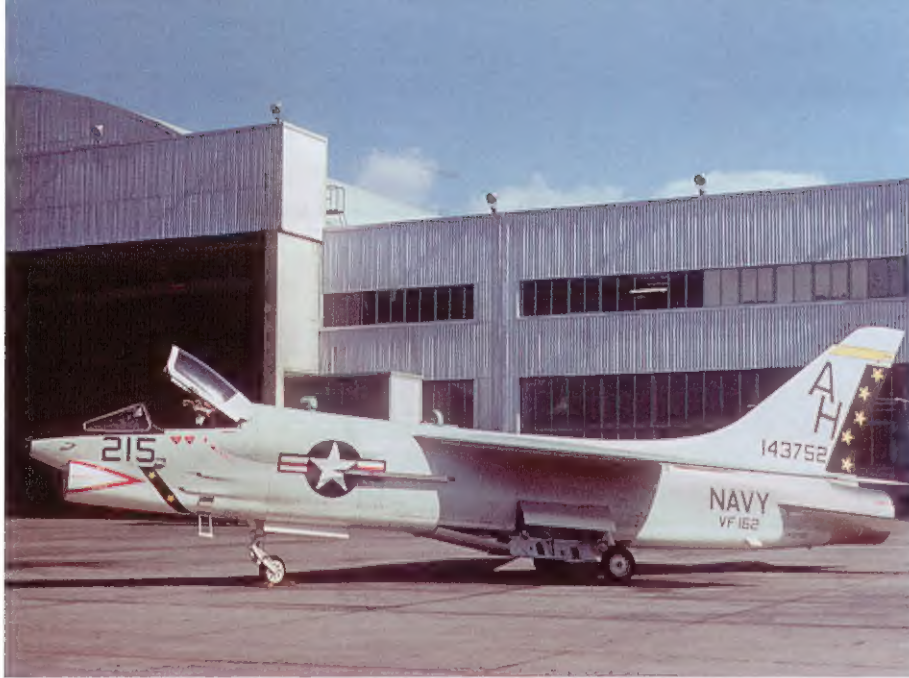
This F8U-1 (AH-215/BuNo 143752) of VF-162 'Hunters' shows this variant's typical configuration with the single rocket rail. The Crusader was painted in the standard period scheme of Light Gull Gray (FS36440) over Insignia White (FS17875), with Insignia White control surfaces and wheel wells. VF-162 was based at NAS Miramar, California. (JEM)

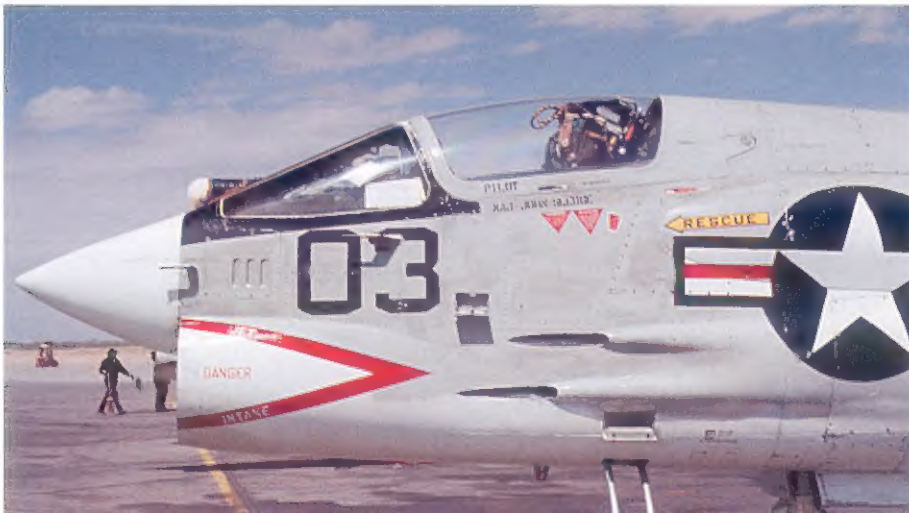
This F-8H's nose profile shows the uneven taper of the upper and lower nose cone surfaces. This resulted from the oval cross section at the fuselage to nose cone interface. The early style flat pitot tube was retained on the F-8H after remanufacture, along with three small cooling vents for the radar system. (Detail & Scale)

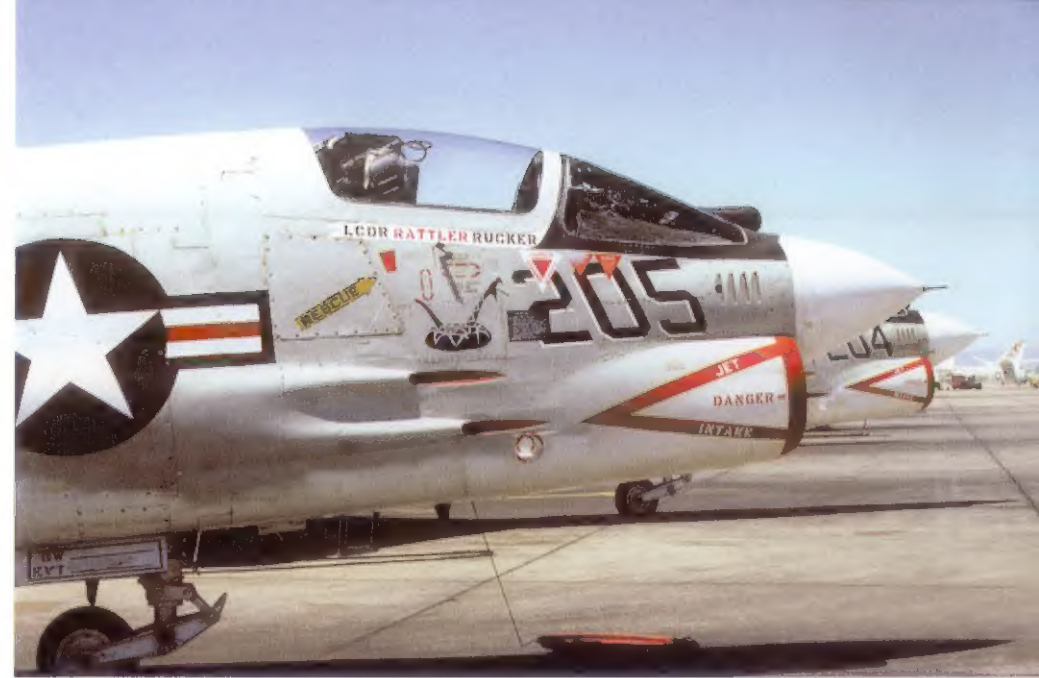
The F-8E/J's right nose side had four cooling vents, as did previous variants. The vents' shape differed on the F-8E/J, which resulted from the tapered fairing required to blend the larger diameter radome to the fuselage. (Trombecky)

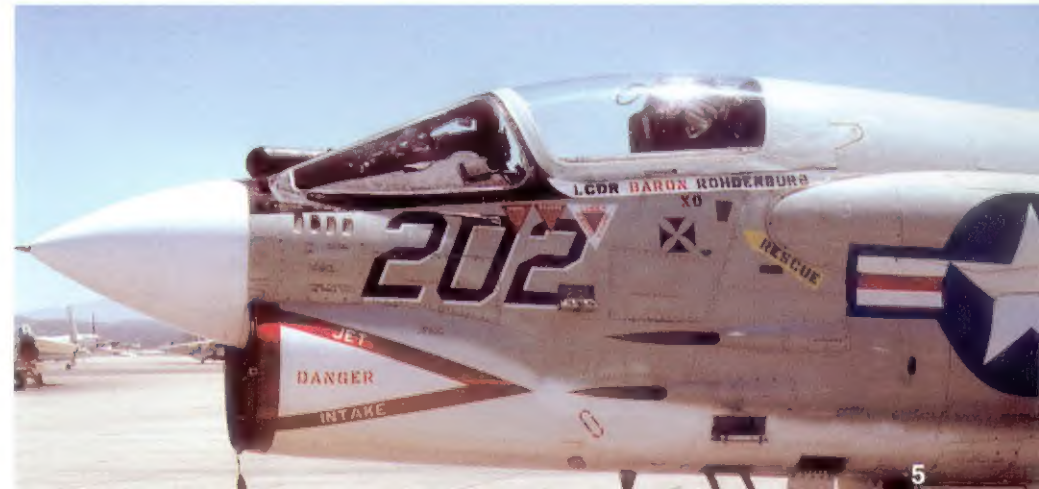
The F-8E/J's left side nose had four radar cooling vents as opposed to the three vents used on other variants. The flat style pitot tube was replaced with a more streamlined Altitude Identification and Measuring System (AIMS) design, which was repositioned below the right windshield panel. This tube provided input for the AAU-19A altimeter. (Trombecky)

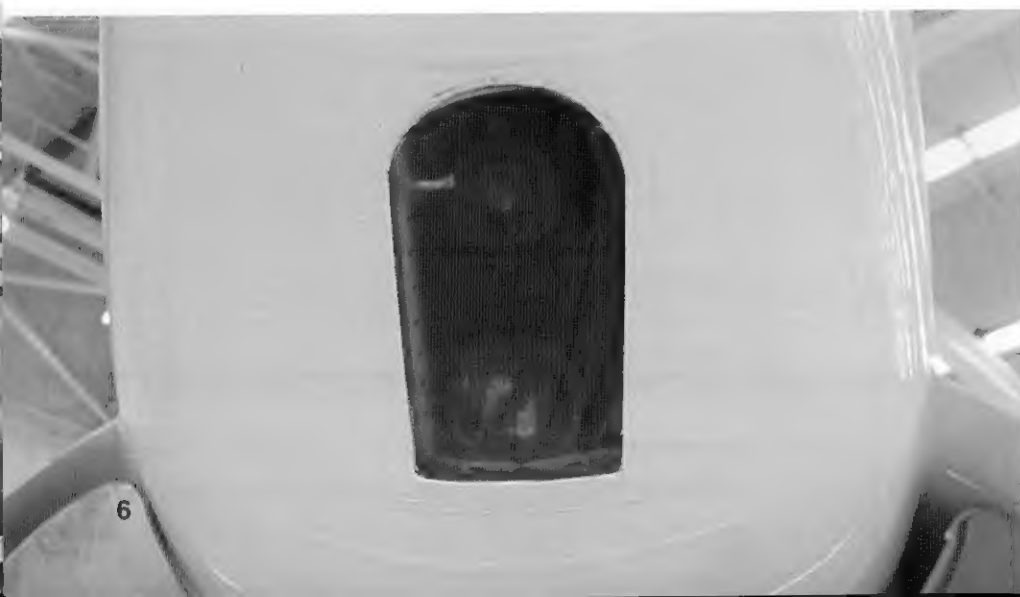
A small, overall cross section nose was featured on all Crusaders except the F-8E, F-8J, and F-8E (FN) variants. The AN/APX-67 radar set mounted in the nose of this F8U-2 (F-8C) has a substantial amount of clearance compared to the larger diameter AN/APX-94 radar set. (Vought)

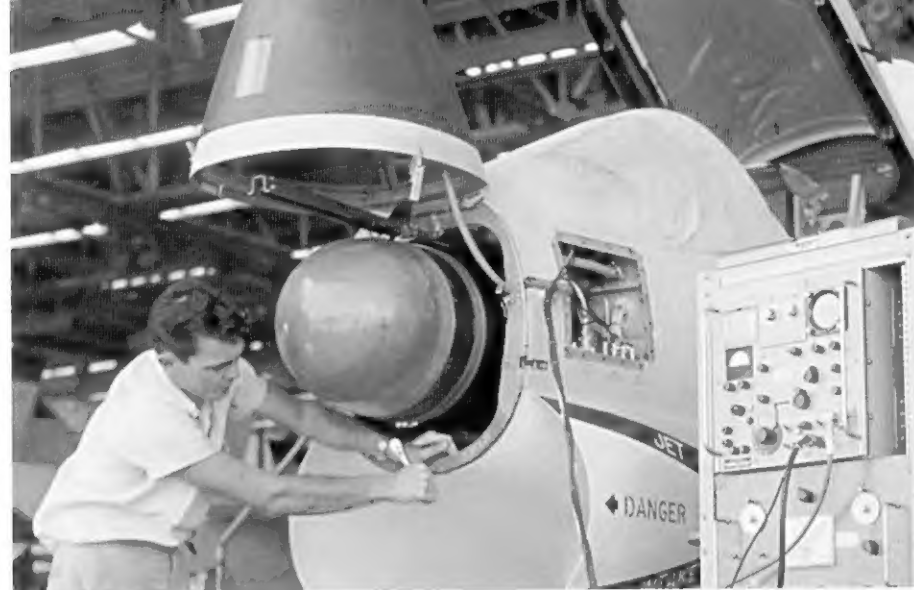
A deck crewman lies within a Crusader's engine inlet. F-8Es were equipped with the Magnavox AN/APQ-94 search and acquisition radar, which had a 21-inch (53.3 cm) diameter dish. To accommodate this larger dish, a circular cross section nose was utilized. This added an additional three inches (7.6 cm) to the Crusader's overall length. The air intake's sharp edge profile reduced buffeting and enhanced boundary layer separation at high speed. (Gottschalk via Mutza)

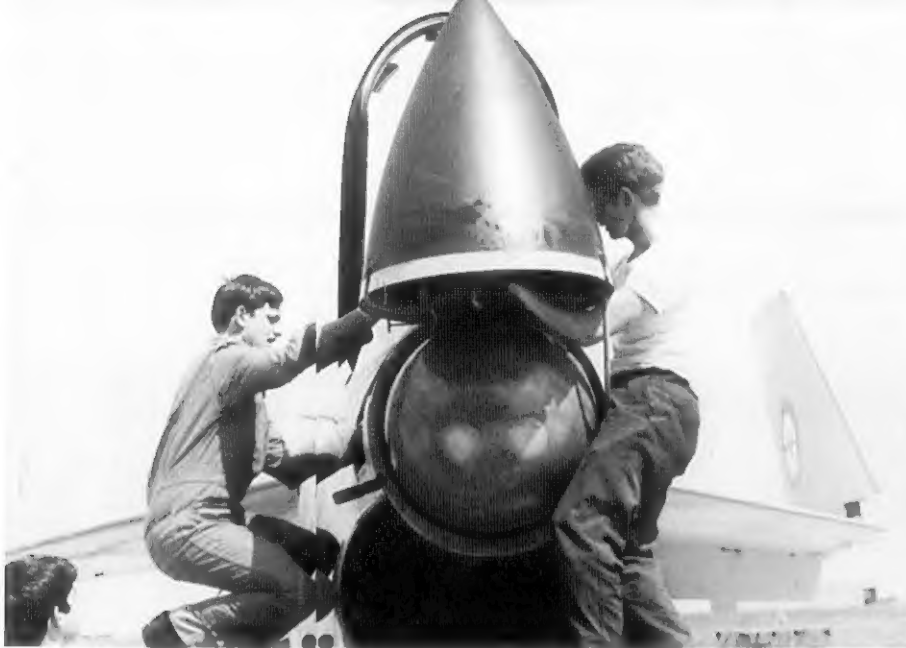
F-8E, F-8J, and F-8E (FN) Crusaders had the 21-inch diameter radar scanner, which required a larger circular nose cone. There was little clearance between the scanner dome and the nose cone. The relative size difference is apparent when compared to the F-8C's AN/APS-67 radome configuration. (DR via Gall)

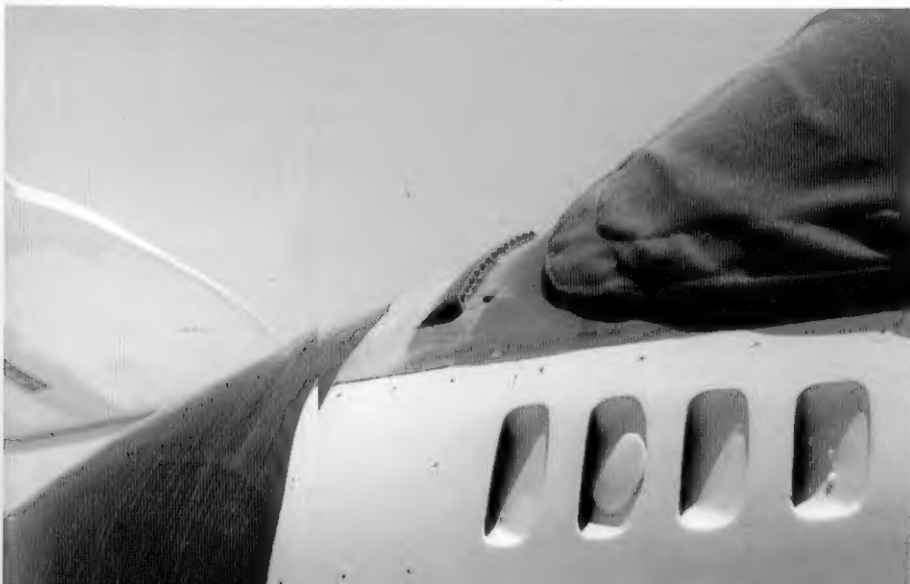
F-8Es and F-8Js had the pitot tube mounted on the center of the 21-inch diameter nose cone. The AN/ASS-15 Infrared (IR) sensor was mounted atop the fuselage just aft of the nose cone seam and at the base of the center windshield panel. All three access steps and both canopy release handles are extended. The gun blast ports have a pronounced contour. (Matsuzaki)

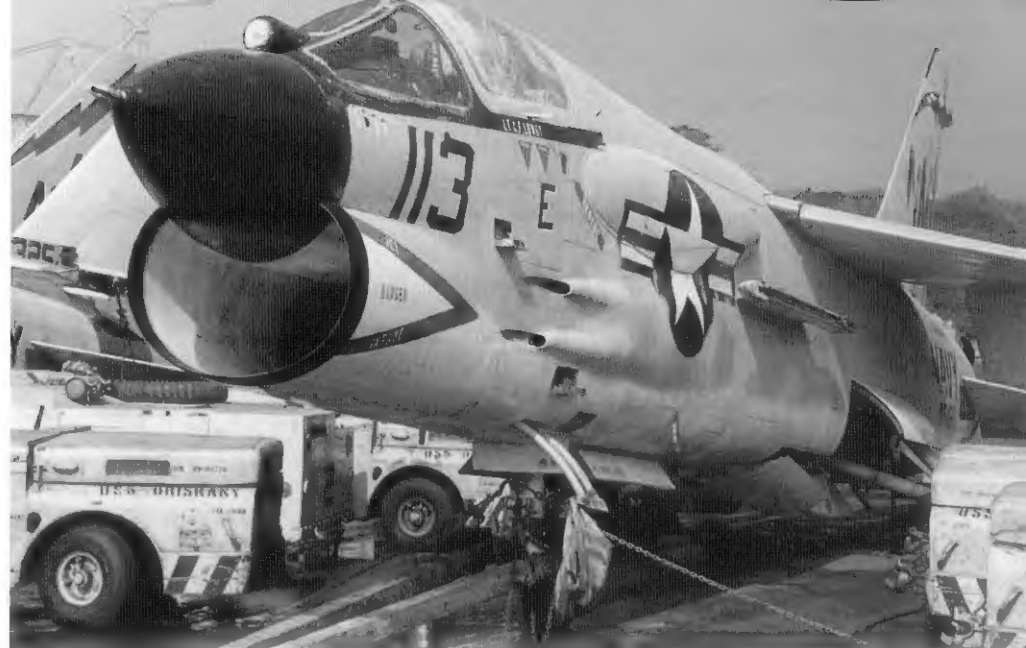
Each F-8 had two Bright Red (FS31136) warning triangles below the windshield's aft edge. The front triangle was for the ejection seat and the aft triangle was for the canopy jettisoning system. Two Bright Red circles that appear like a figure '8' outlined the static port sensor openings. The Bright Red RESCUE arrow was 20 inches (50.8 cm) long and three inches (7.6 cm) wide at its widest point. (Vought)

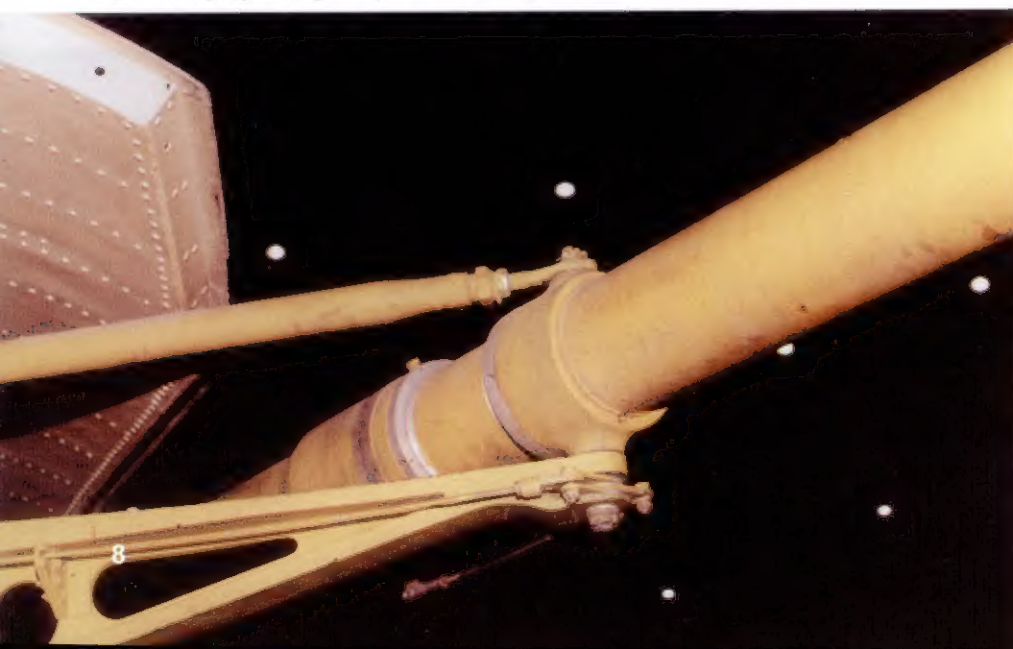
The main support 'A' frame was made of cast aluminum and was hinged to the fuselage at station 244. A pivoting transfer cam was mounted on the 'A' frame outer hinge, which connected to locking pin tie rods. The locking pin was located at the probe connector housing's lower aft end, which was on the probe's lower surface. (Nick)

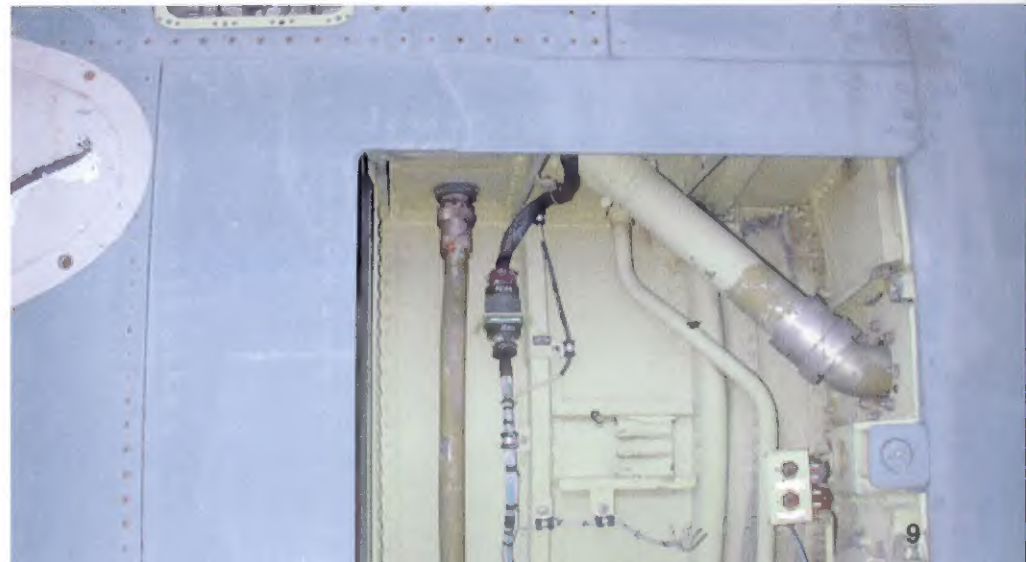
All Crusaders had the intake duct bypass door located on the left fuselage side just aft of the in-flight refueling probe housing. This door had an angular configuration at the lower forward edge on F-8 fighters; RF-8 reconnaissance aircraft had a square door. The aft-hinged door was removed on this Crusader. It was opened either manually or automatically to reduce intake duct ram air pressure at high airspeeds. (Weinel)

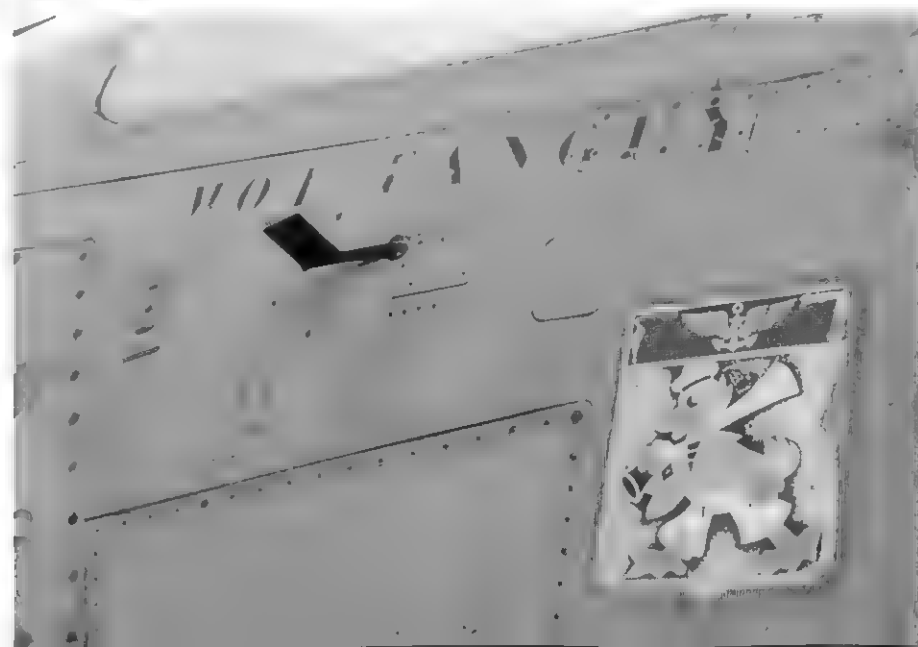
The Angle of Attack (AoA) transducer vane was mounted on the right fuselage side just below the canopy sill on all F-8s. This transducer sent a signal to the indicator that gave the fuselage's relative angle to the airstream. The AoA transducer also controlled the approach indicator lights mounted on the pilot's display and the nose gear flipper door. The insignia of the French Navy's *Flotille* (Squadron) 12F is painted near the AoA transducer. (Lubin)

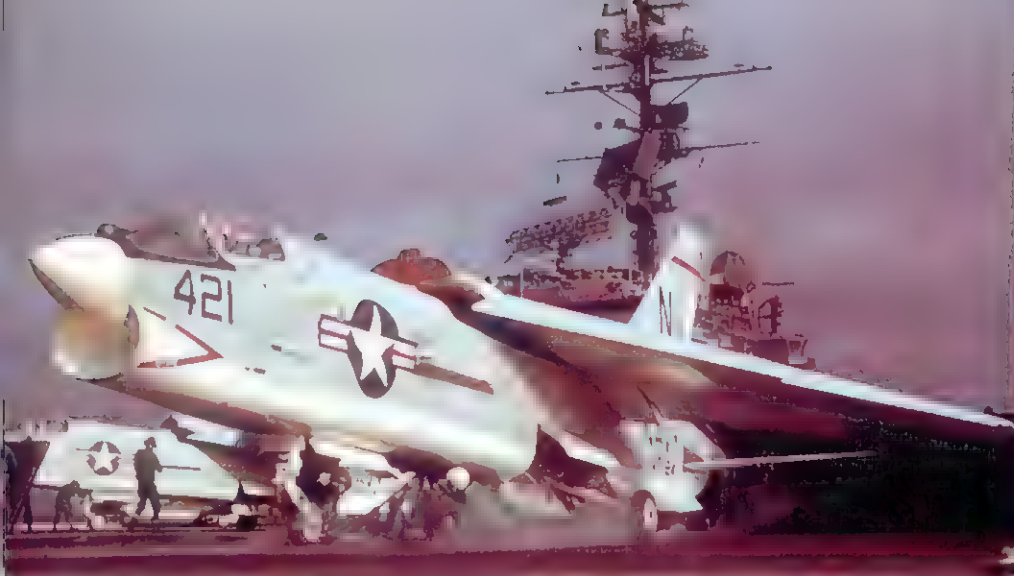
A VF-124 F8U-2NE (F-8E) (NL-421) prepares to launch on a training mission. This was the final production Crusader variant. It had the improved AN/APQ-94 fire control radar and a large diameter scanner in the nose that required a slightly larger nose cone. The AN/ASS-15 Infrared (IR) sensor was installed in the front of the windshield and additional fire control equipment was mounted in a 'hump' atop the wing center section. (Vought)

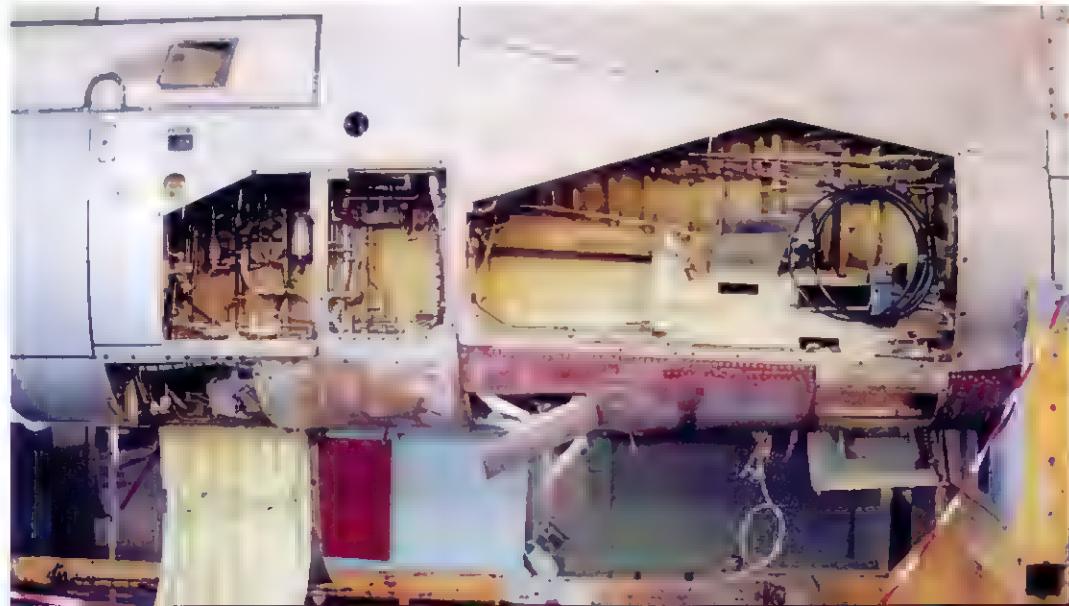
The F-8 was equipped with an EPP mounted in a compartment on the mid-fuselage's right side. This system provided both emergency electrical and hydraulic power. Its extension mechanism was powered by pneumatic pressure from the adjacent 1100-cubic inch pneumatic storage bottle. A fixed displacement hydraulic pump was mounted to the assembly's aft end. (Weinel)

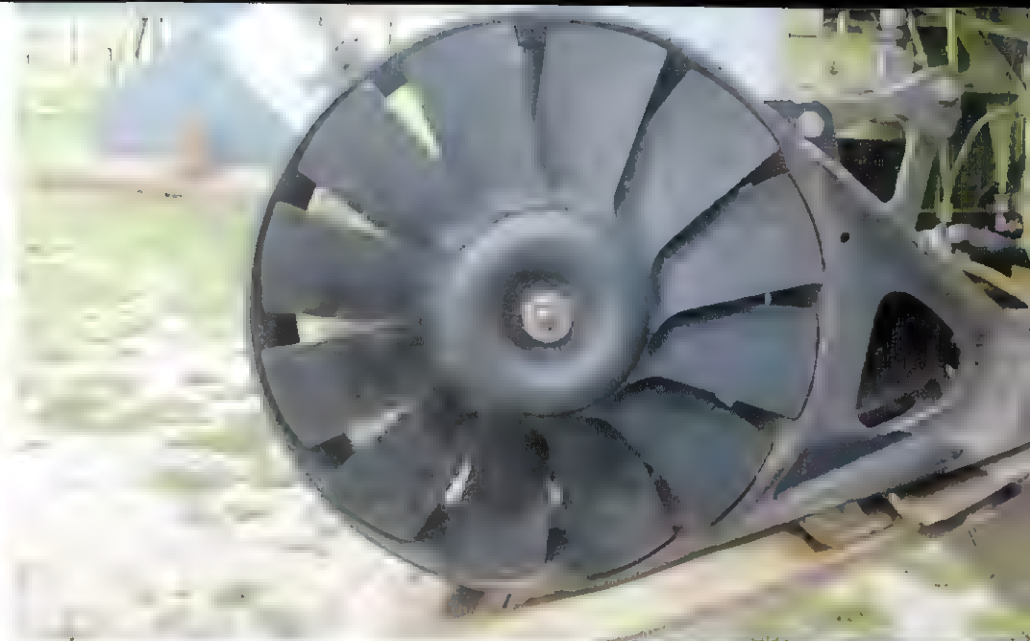
The EPP system's main component was the Marquardt Ram Air Turbine (RAT). The RAT consisted of a 12-inch (30.5 cm) diameter turbine, which drove an Alternating Current/Direct Current (AC/DC) generator integrally mounted aft of the turbine. (Weinel)

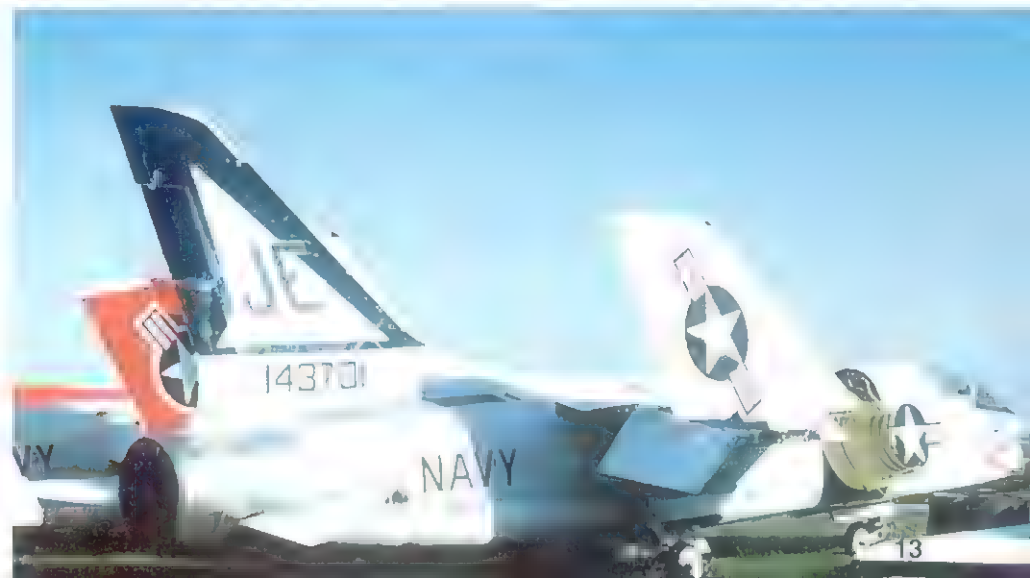
Early F-8s through the F8U-2 (F-8C) were equipped with a large equipment compartment atop the fuselage, immediately in front of the wing. Compartment access was via a large hatch that was hinged on the right edge where it connected to the fuselage. This was commonly referred to as the 'Buick Hood' because of its similarity to the 1941 to 1951 Buicks. (JEM)

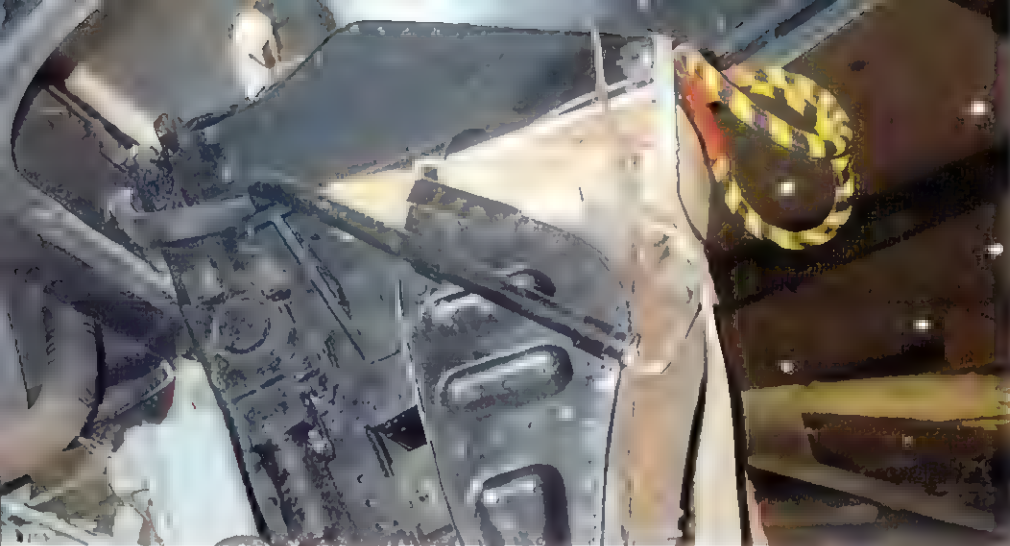
The F8U-2 (F-8C) and subsequent Crusaders replaced the Vought ejection seat with this Martin-Baker Mk-F5A. This was due to the Vought Seat's basic limit to high altitude ejections, while the F5A was used at most altitudes and airspeeds. Vought developed retrofit kits that allowed installation of the Mk-F5A into earlier Crusader variants. (Nick)

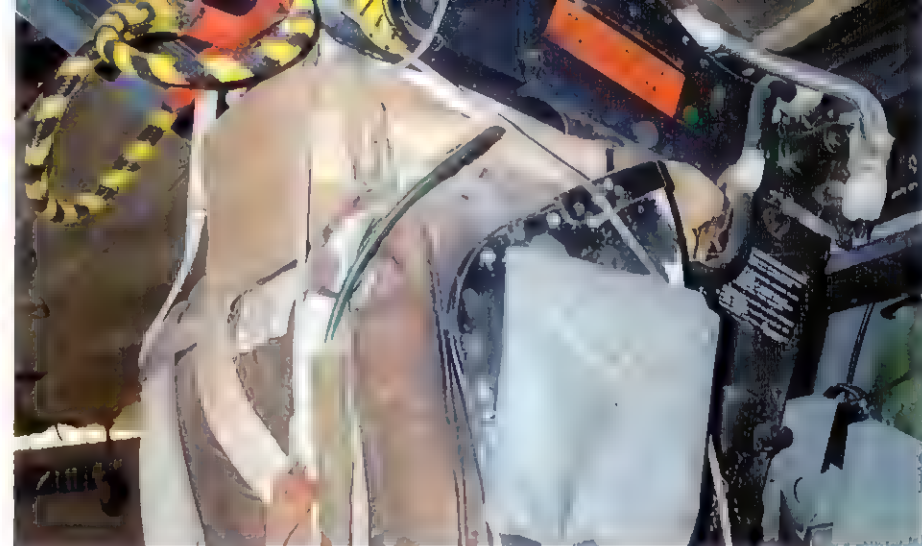
The Mk-F5A seat was readily identifiable by a Red decal located on the drogue parachute container's left side. This decal identified the seat model number and operational limits. A Yellow and Black canopy interrupter D-ring mounted in front of the decal was an emergency seat backup arming device. This was used when the canopy did not separate from the aircraft. The seat safety pin was contained within the Dark Gull Gray pocket on the parachute pack support frame. A wedge pad mounted above the parachute pack served as the pilot's headrest. (Nick)

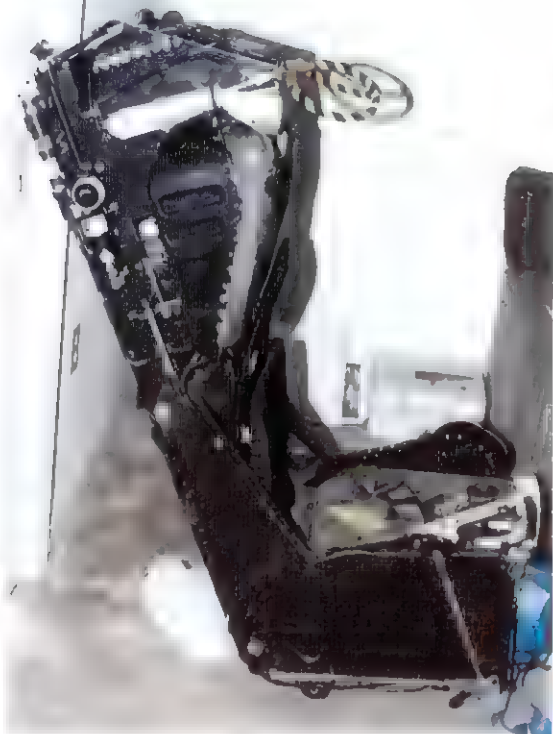
(Left) Naval Air Systems Command (NAVAIR) Airframe change (AFC)-491 specified replacing the F-8's Mk-F5A ejection seat with this Martin-Baker Mk-F7 seat. This provided the Crusader with a true 'zero-zero' ejection capability. The Mk-F7 allowed the pilot to escape from a crippled aircraft at zero altitude and zero airspeed. (Nick)

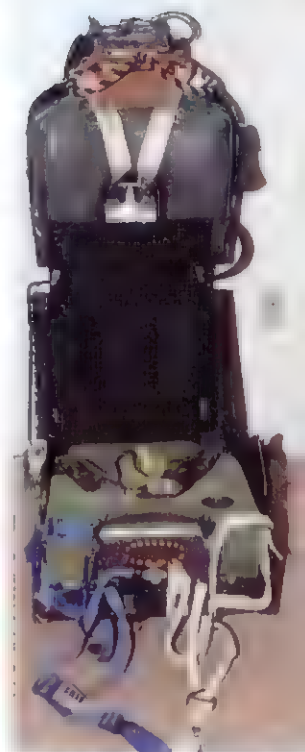
The Mk-F7's seat bucket contained the same RSSK-6 survival kit employed on the Mk-F5A seat. The upper half contained the emergency oxygen bottle, while the lower half held a life raft, radio transmitter, and survival equipment bag. The leg restraint release lever was located on the left seat frame's lower front edge. The shoulder harness lock lever was mounted on the top edge of the left side seat frame above the leg restraint lever. (Nick)

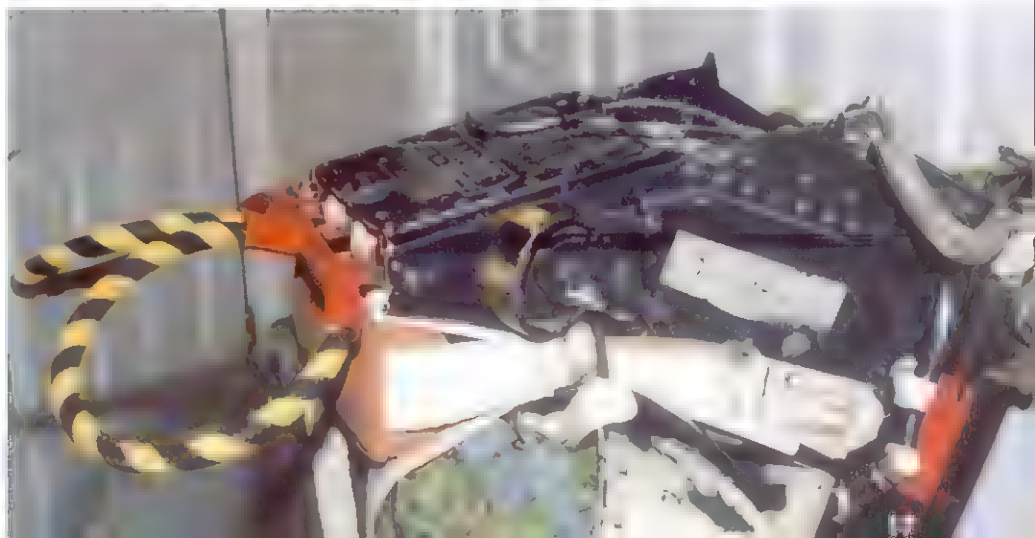
Pivot arms at the canopy frame's aft end attached the F-8's one-piece clamshell-type canopy to the fuselage. This canopy was manually operated and locked. A counterbalance strut aided the pilot in raising and lowering the canopy without the aid of power devices. (Weinel)

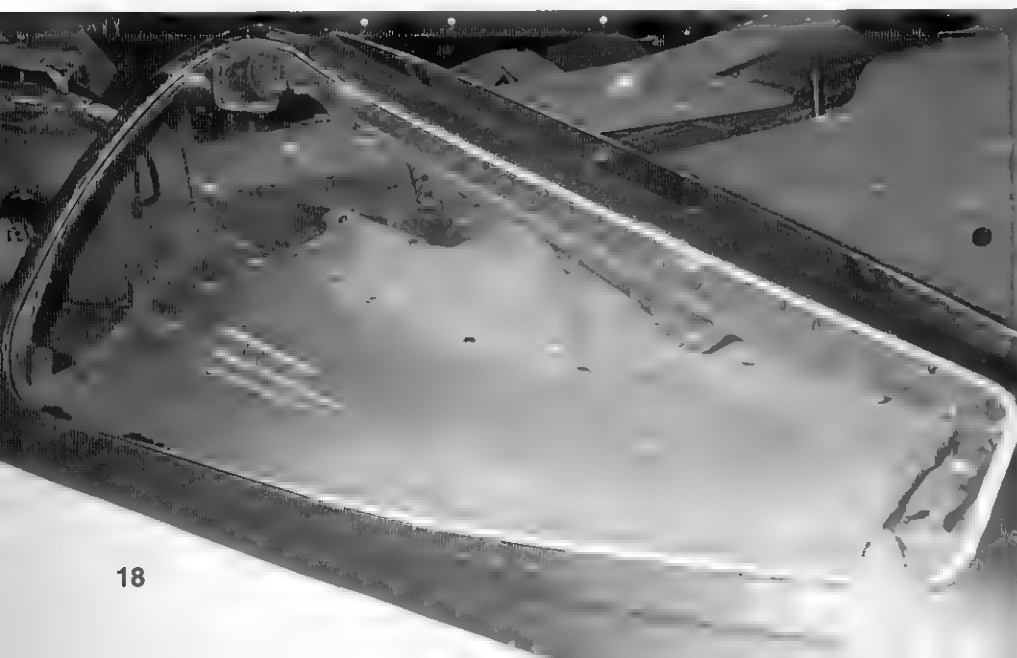
The area behind the pilot's seat and under the aft canopy bulkhead contained a cartridge-operated emergency canopy actuator. The corrugated hose in the center provided temperature-controlled air for the canopy defogging and air conditioning ducts. The 1.3-gallon (5 L) spherical oxygen storage bottle was located on the aft edge of this shelf. This bottle was painted Light Green (FS14187). (Nick)

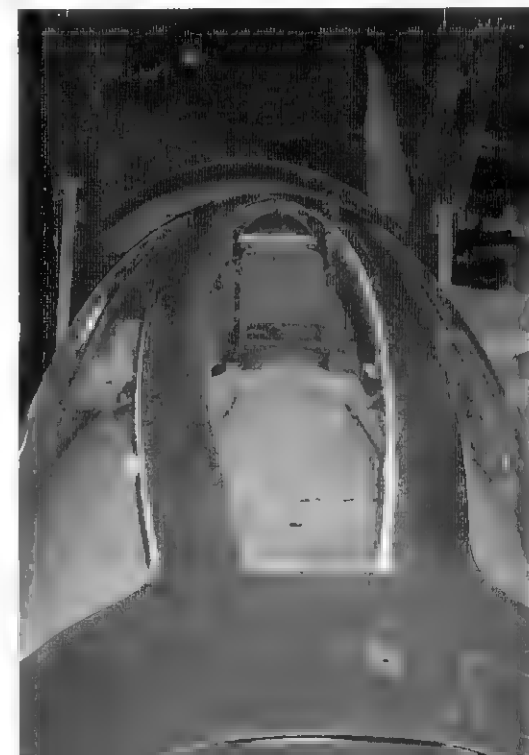
The windshield's center panel was made of 1-inch thick bulletproof glass. This panel was optically coated to reduce glare and improve gun sight Head Up Display (HUD) visibility. The HUD was located above the instrument panel shroud, directly below the center glass panel. (Nick)

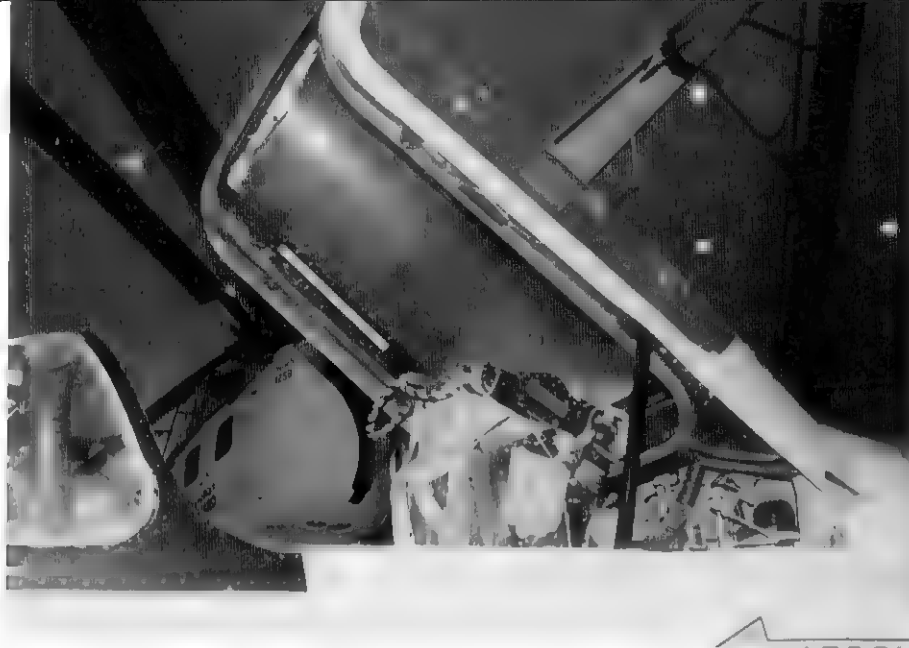
The single-piece plexiglass canopy was built into a cast magnesium frame. This canopy was locked in the closed position by four rotating hook latches mounted in the cockpit sill. A striker and diaphragm arrangement achieved the pressurized canopy seat. The seal diaphragm ran the periphery of the inner canopy frame edge and rested on a raised rib fixed to the fuselage frame. (Dann)

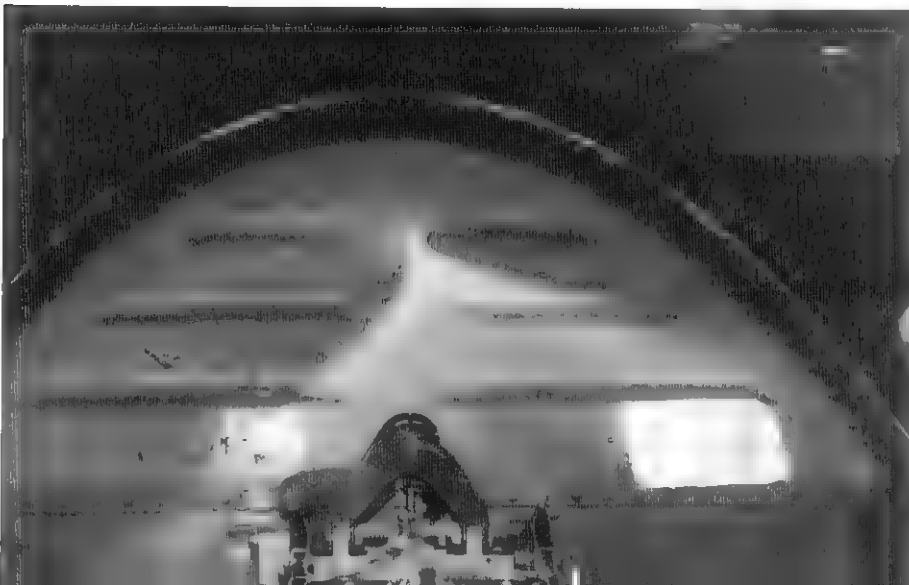
The canopy aft bulkhead was built from formed aluminum with reinforcing ribs for structural rigidity. This Flat Black (FS37038) bulkhead was devoid of any wiring or attachments except for an aircraft data plate and an ejection seat information panel. (Nick)

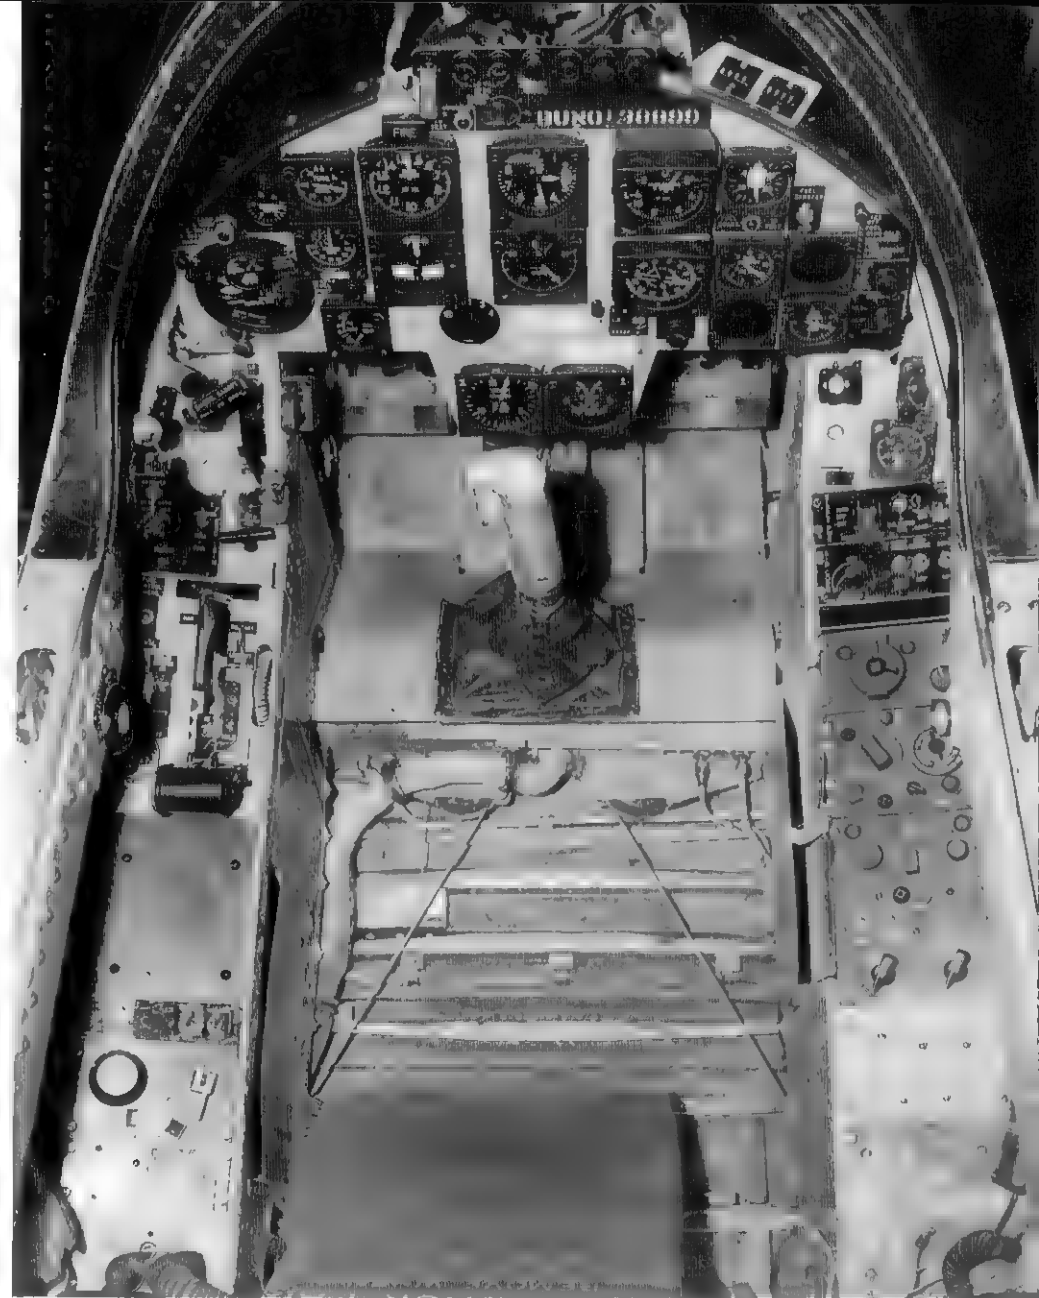
The first XF8U-1 prototype (BuNo 138899) cockpit layout established the general pattern for all Crusaders. The pilot's main instrument panel contained all the primary flight instruments, while the right console contained the electronics and communication instruments. The left console held the throttle, fuel control, and hydraulic controls. The prototype had a simple straight control stick that included yaw and roll trim adjustment switches. (Vought)

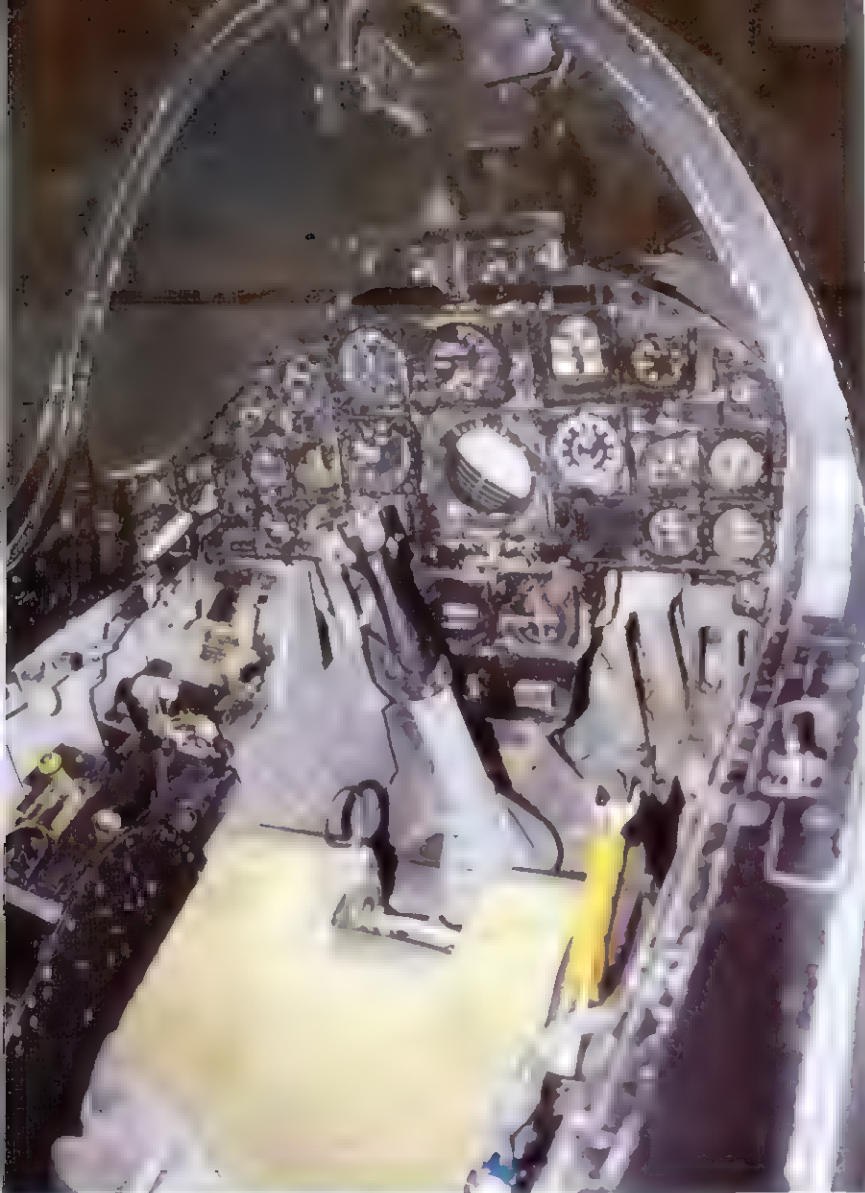
The F8U-1 (F-8A) cockpit followed the XF8U-1's general arrangement. The gun sight reflector was mounted directly in front of the pilot on the windshield's top edge. The Angle of Attack (AoA) approach indexer is mounted to the sight's left, while the auxiliary compass is located to its right. A rectangular armament panel is mounted atop the instrument panel, while primary flight instruments are installed on the instrument panel. (Detail & Scale)
